Implant screw fracture: a case report

Christopher Lambert-Rose tackles abutment screw loosening, a recognised complication of implant placement

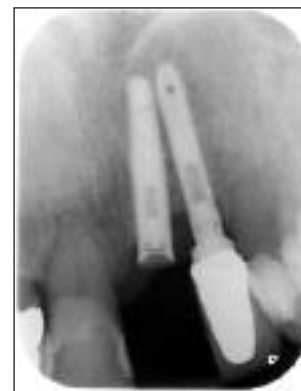
A 64-year-old man self-referred regarding a crown fracture on his implant at site 21. Two days previously, the patient had bitten into some hard food and the crown separated from the implant. The Osteo TI implant had been placed about five years previously, together with an implant at site 22. About 12 months ago, the crown at 21 had become loose, but ill health and mobility problems had prevented the patient from seeking treatment. Examination revealed an implant at 21 with the abutment screw retained within and below the head of the implant. The other half of the screw was in the crown (see Figure 1 below).

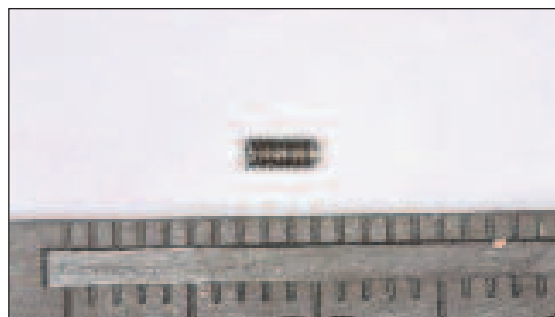
Patience is required at this point, as the screw moved very slowly at first and it took some 15-20 minutes of alternately using gooseneck bur and endodontic scaler tip to eventually remove it from the implant (see Figure 4 left).

implant. A larger gooseneck bur was then used very carefully, taking care to avoid damaging the internal thread. The depression helped it positioned centrally on the screw. Friction, from the anti-clockwise rotating bur, moved the screw anti-clockwise and out of the implant.
