Implant screw fracture: a case report

Christopher Lambert-Rose tackles abutment screw loosening, a recognised complication of implant placement

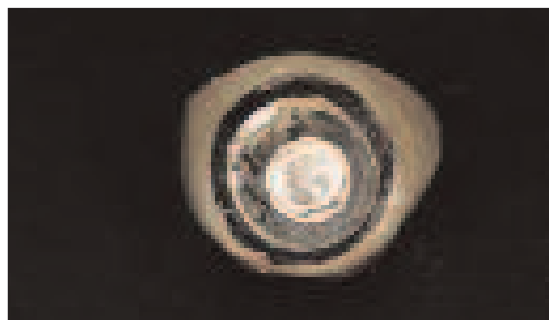
A 64-year-old man self-referred regarding a crown fracture on his implant at site 21. Two days previously, the patient had bitten into some hard food and the crown separated from the implant. The Osteo TI implant had been placed about five years previously, together with an implant at site 22. About 12 months ago, the crown at 21 had become loose, but ill health and mobility problems had prevented the patient from seeking treatment. Examination revealed an implant at 21 with the abutment screw retained within and below the head of the implant. The other half of the screw was in the crown (see Figure 1 below).
